Wetland Delineation Report

**Port of Catoosa
Inola Industrial Rail Facility
Rogers County, Oklahoma**

Report Date: October, 2020

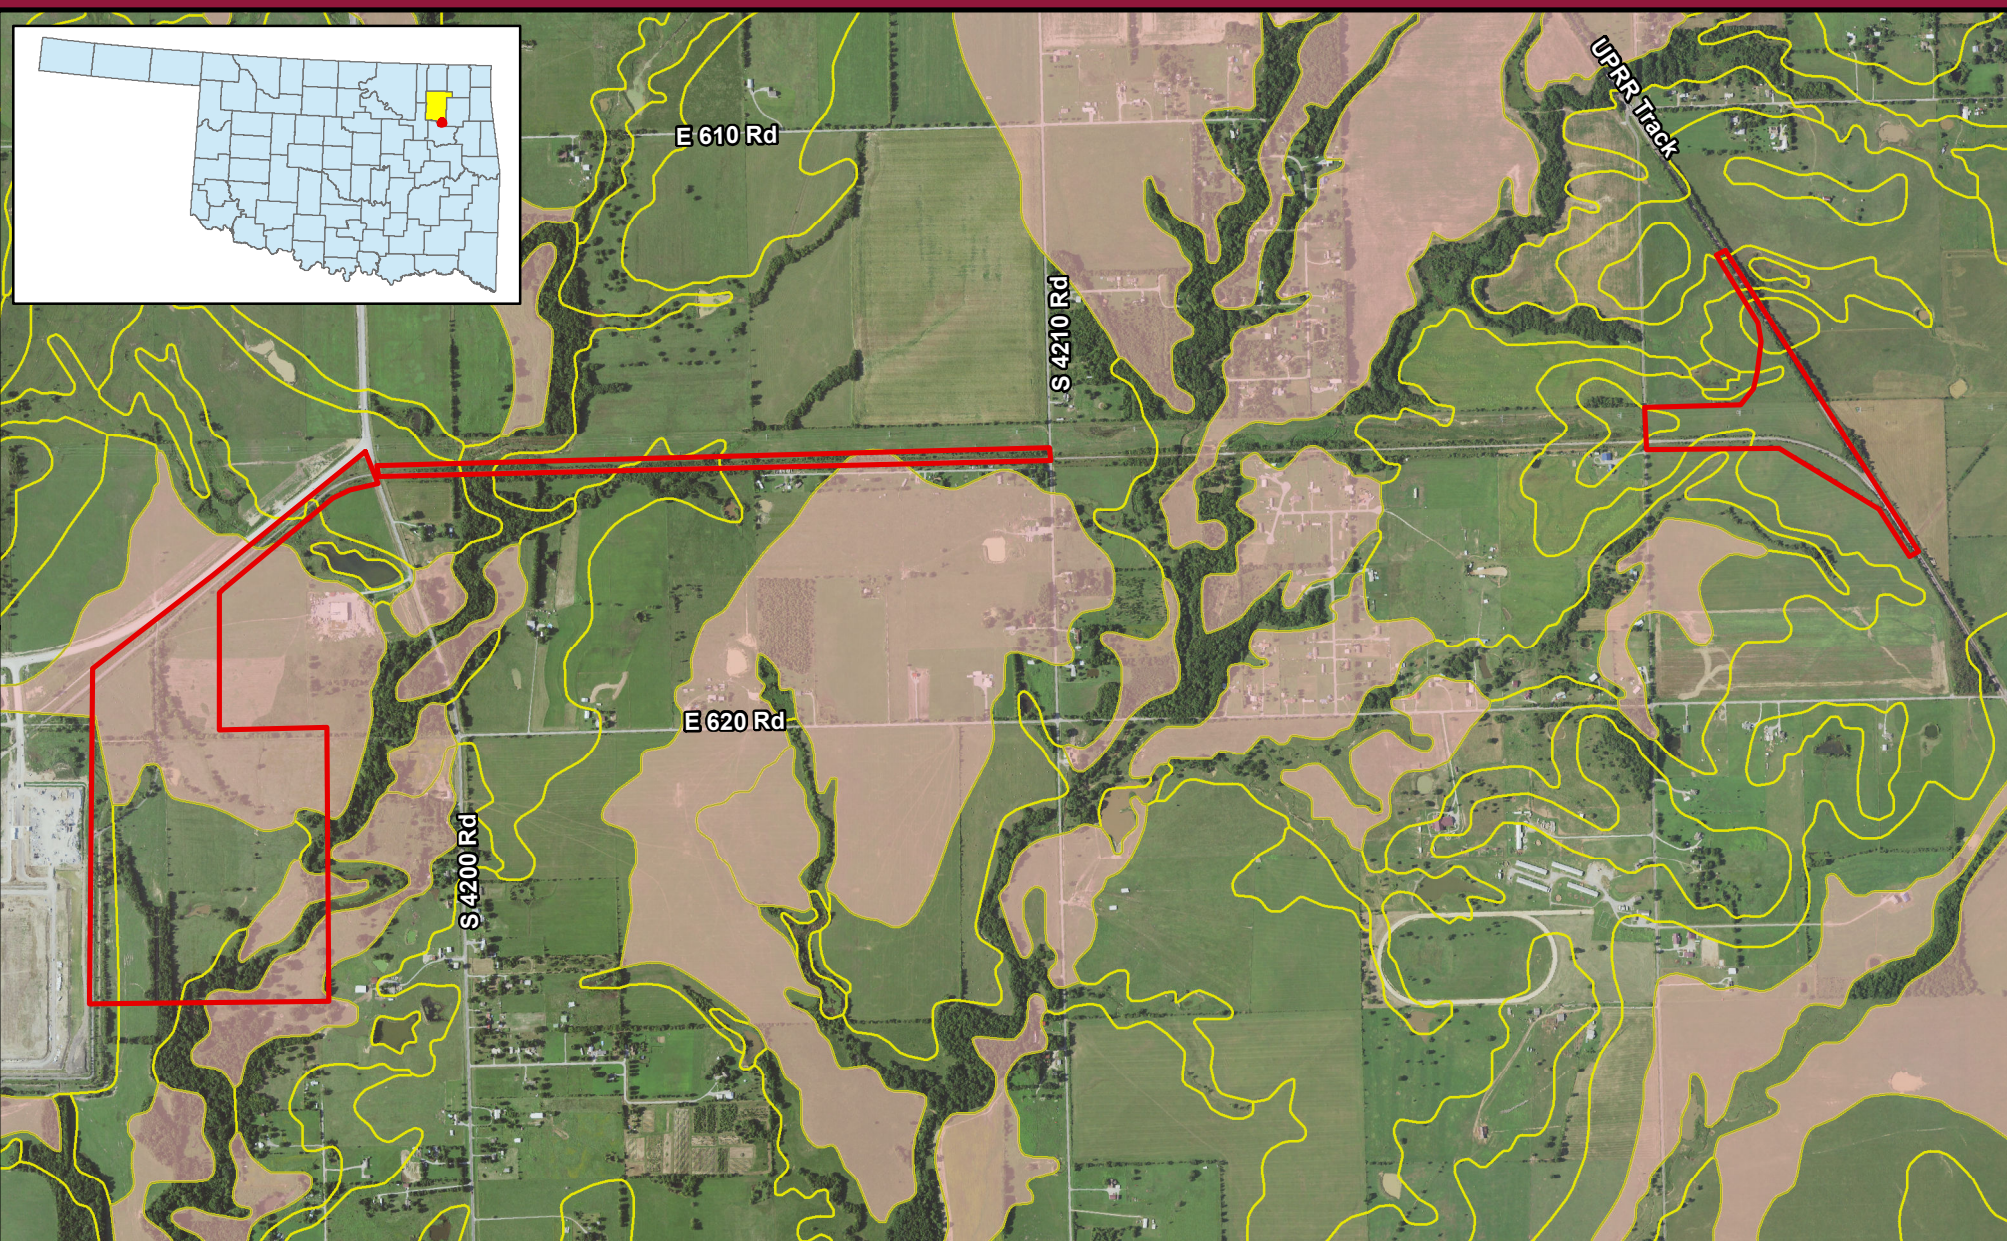
**Figure 3:
Hydric Soils Map**

- Study Area
- Soil Boundary
- Hydric Soil
- Soils with Hydric Components

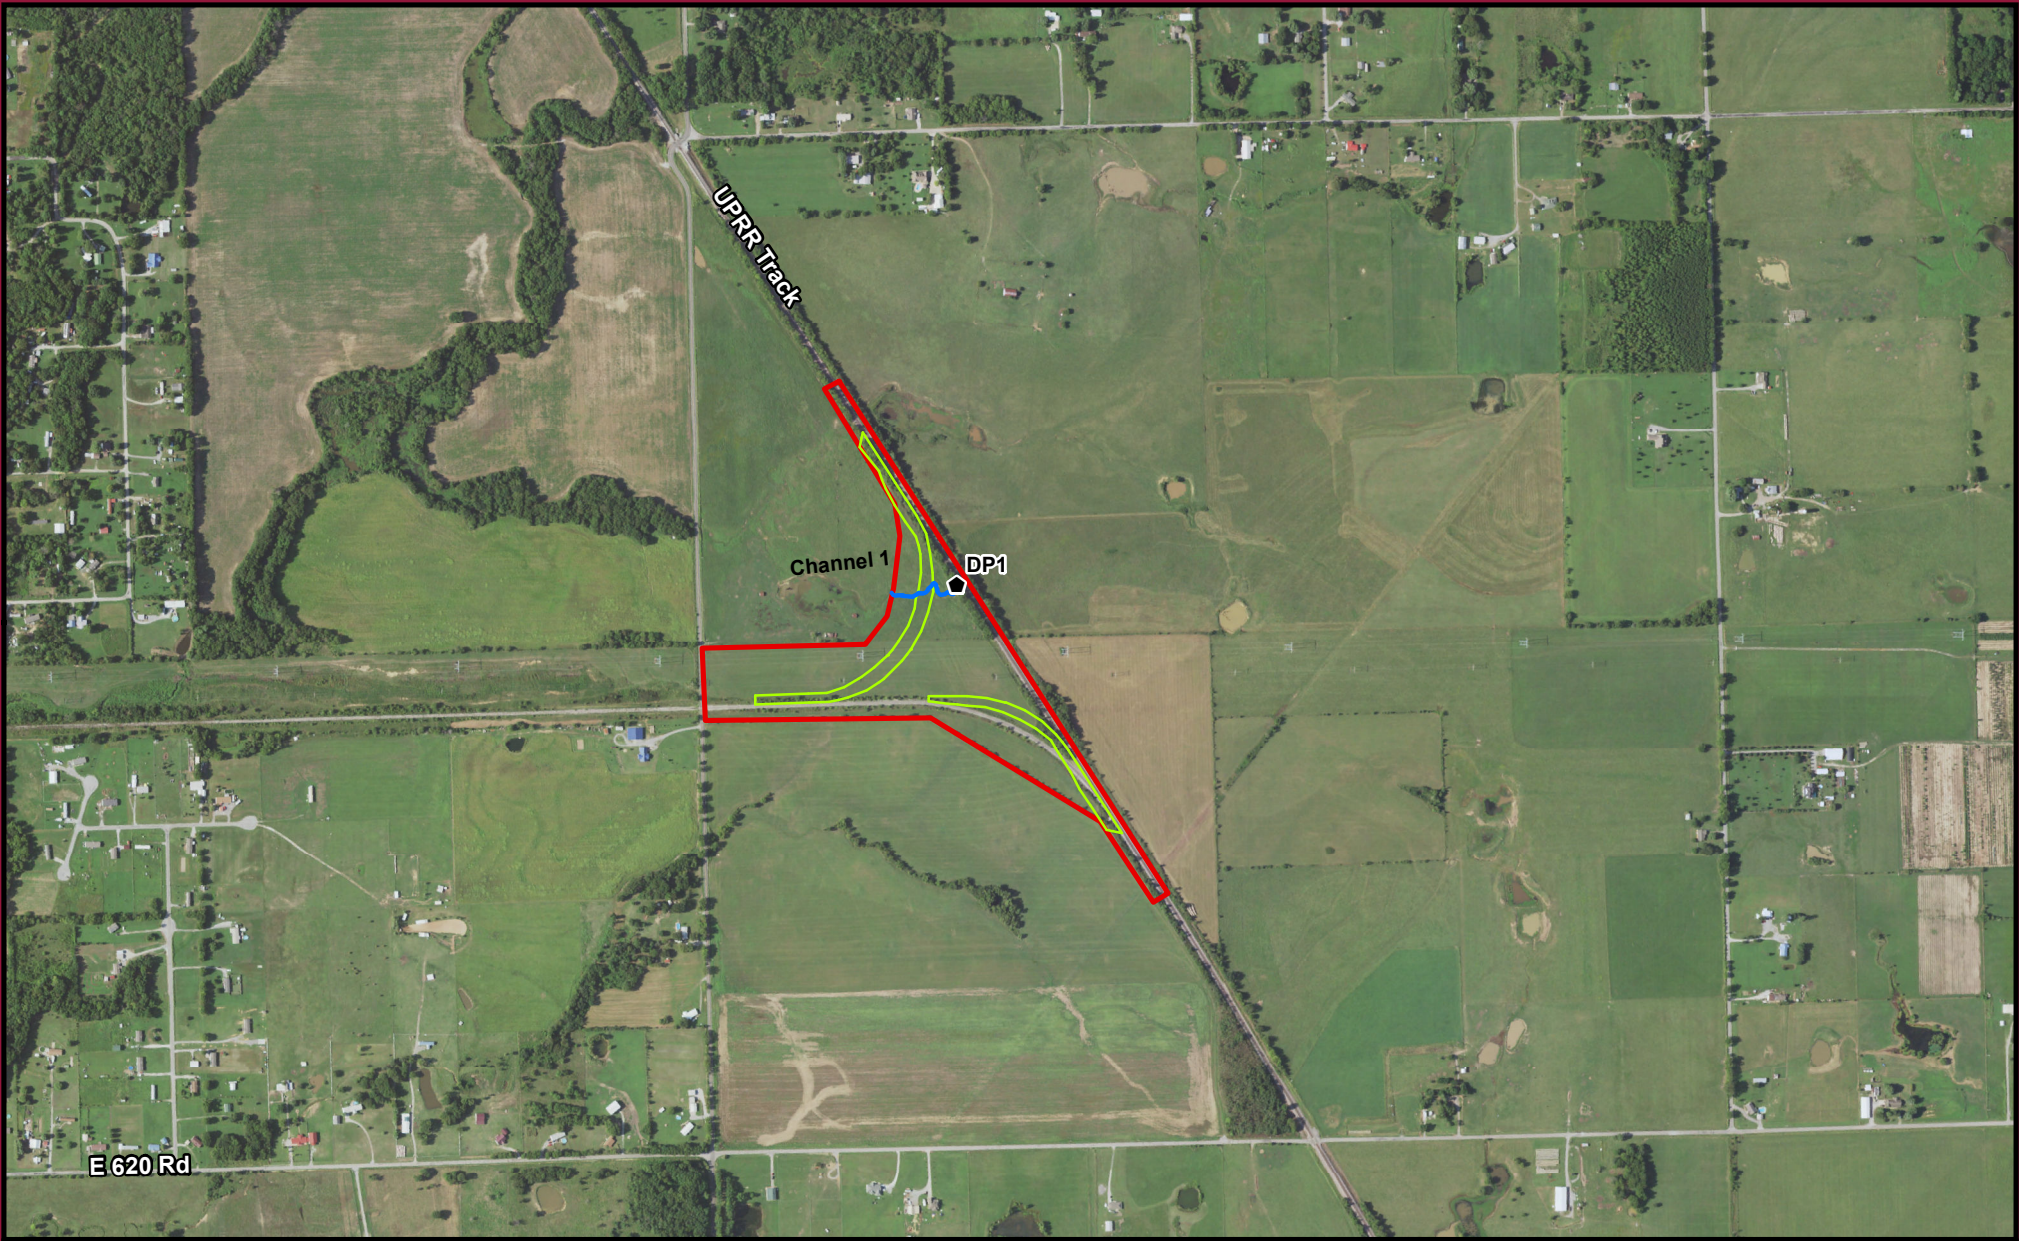
**Figure 5a:
Delineation Map - East**

- Study Area
- Preliminary Construction Limits
- Data Points (DP)
- OHWM
- Emergent Wetland
- Open Water
- Shrub Wetland

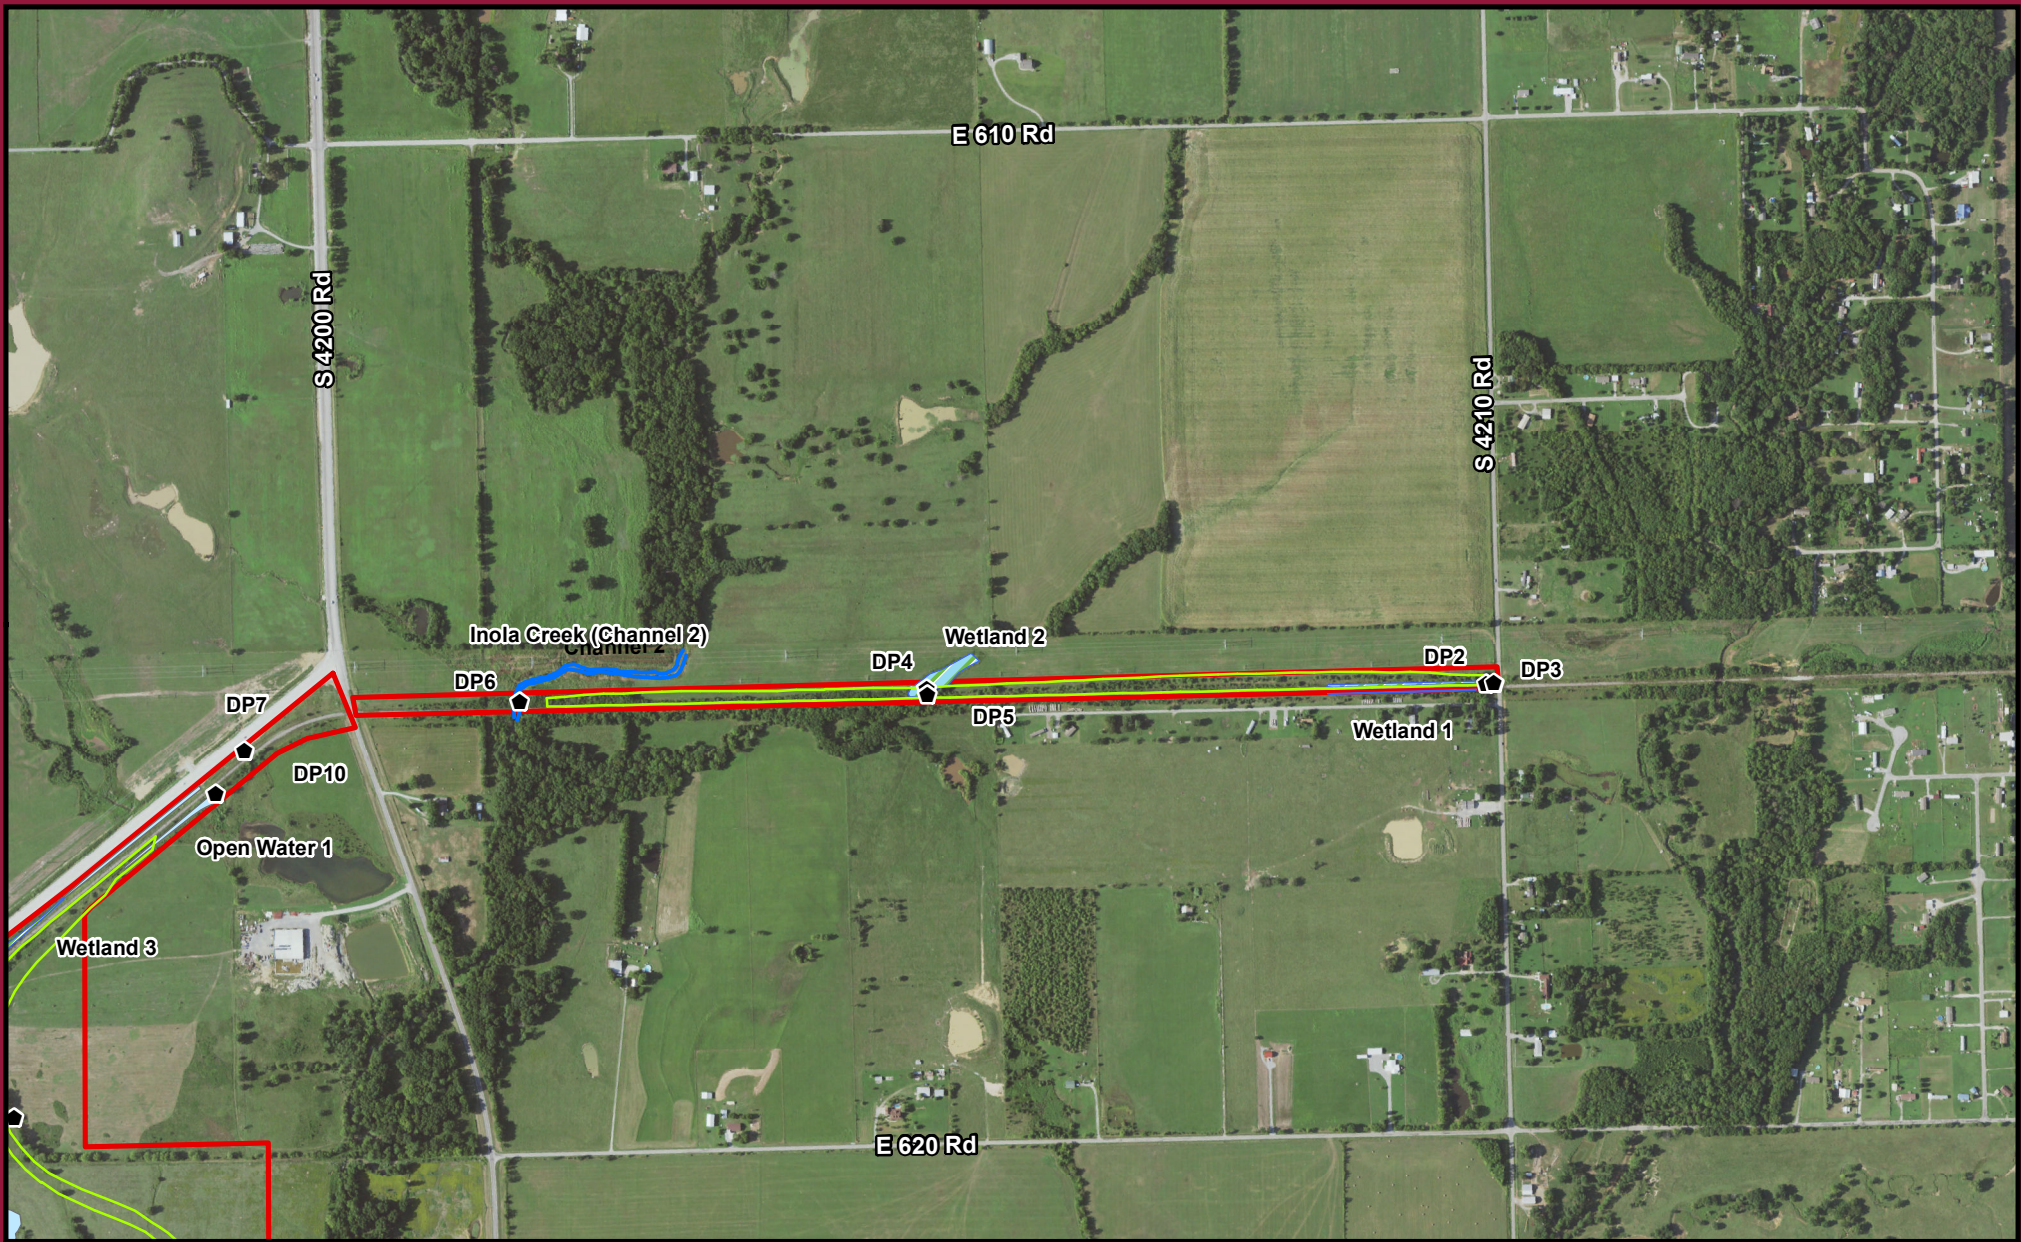
**Figure 5b:
Delineation Map - Central**

- Study Area
- Preliminary Construction Limits
- Data Points (DP)
- OHWM
- Emergent Wetland
- Open Water
- Shrub Wetland

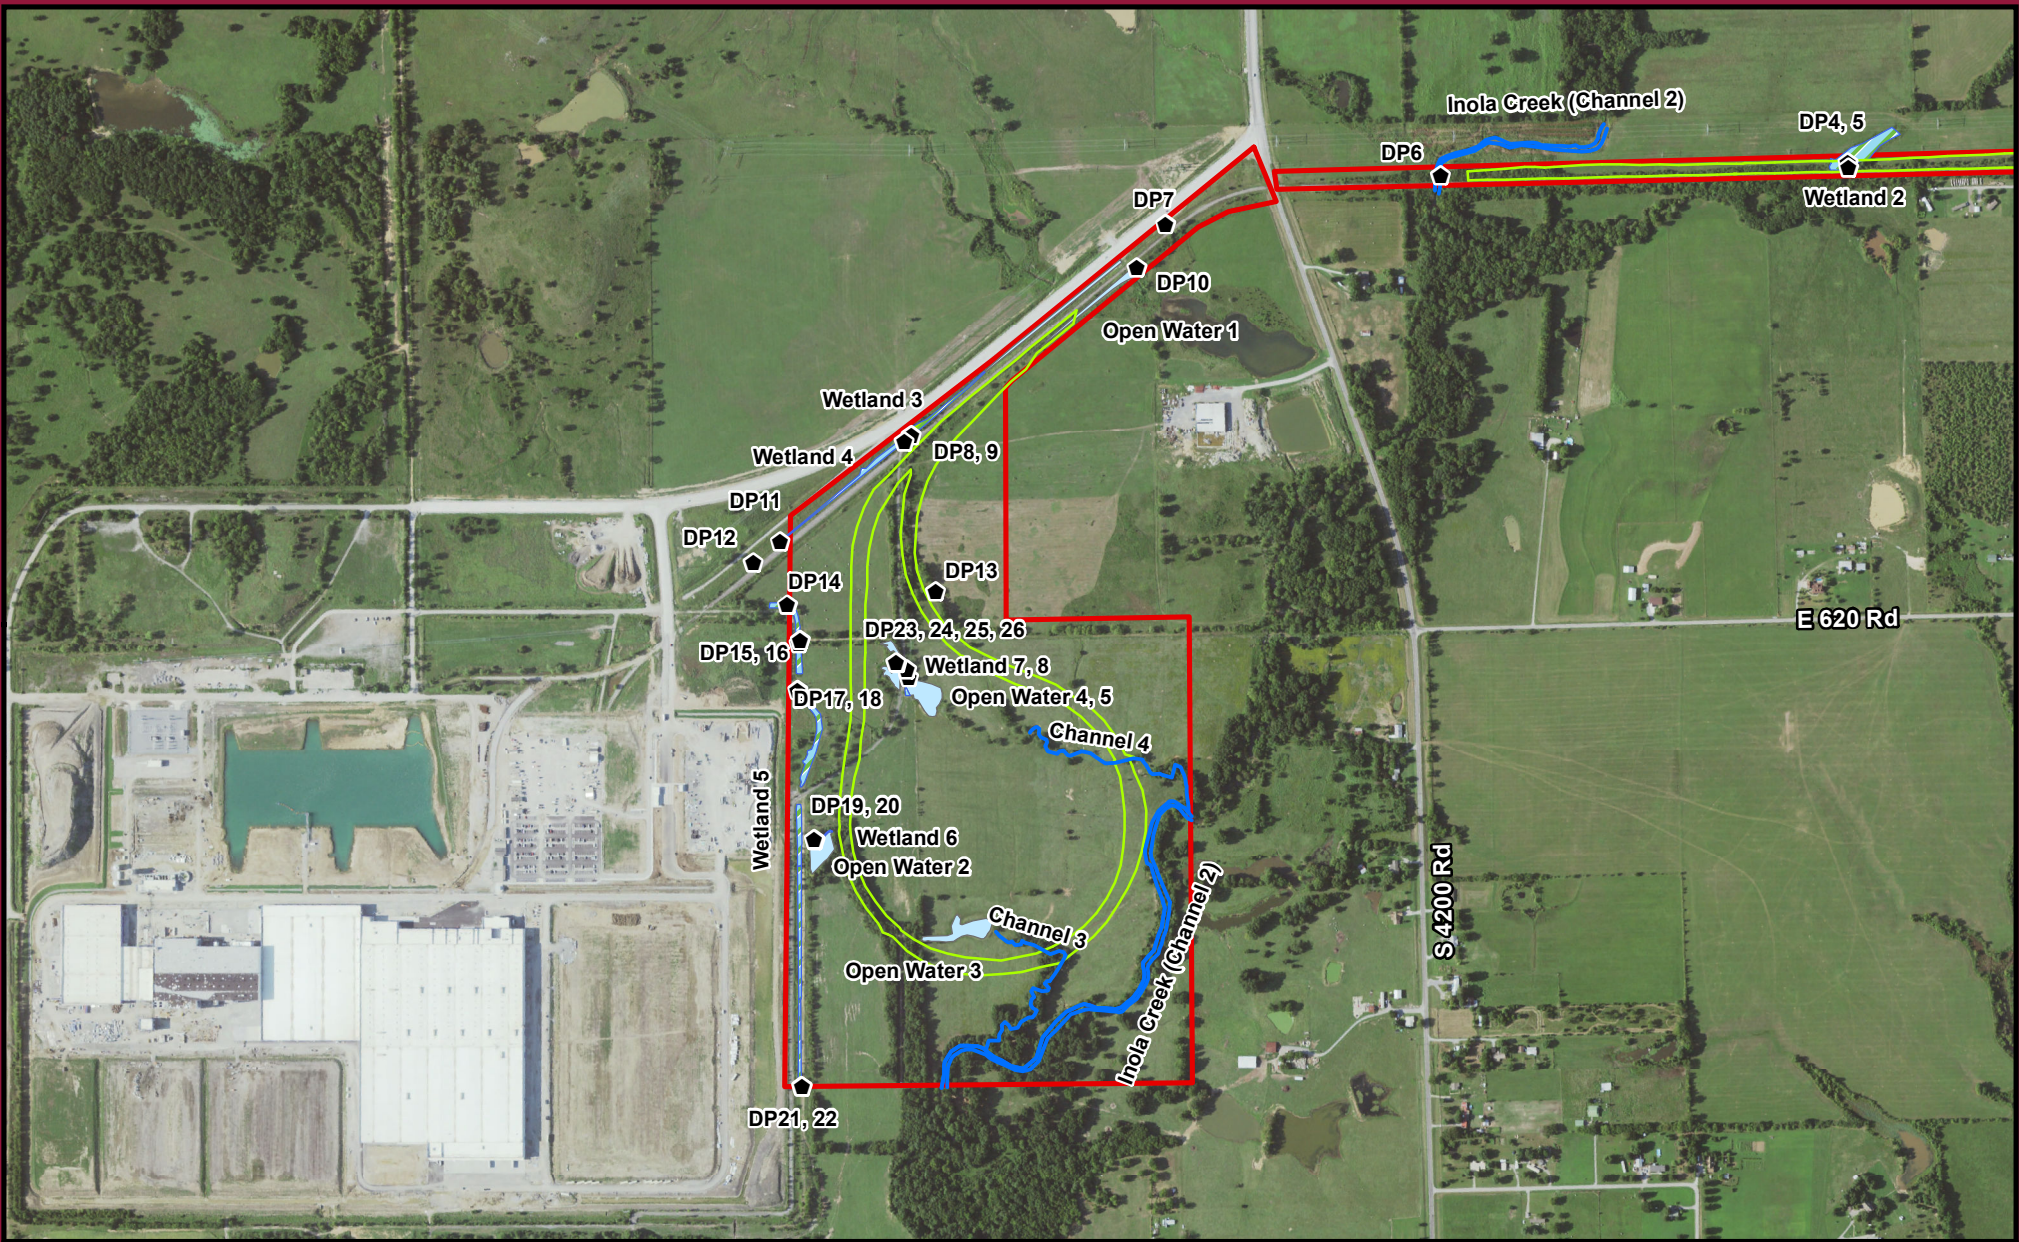
**Figure 5c:
Delineation Map - West**

- Study Area
- Preliminary Construction Limits
- Data Points (DP)
- OHWM
- Emergent Wetland
- Open Water
- Shrub Wetland

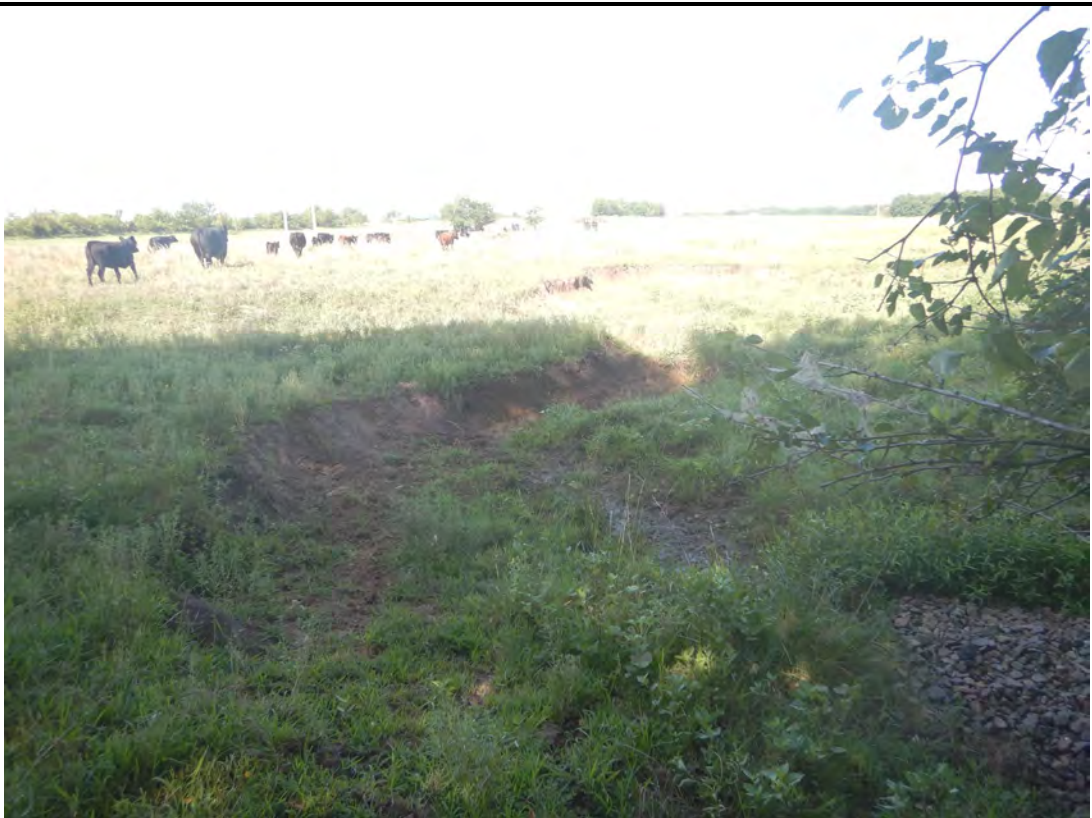
Channel 1 is located at in the northeast section of the project area adjacent to the UPRR mainline track. Channel 1 is an ephemeral channel flowing from east to west through a culvert under the UPRR track. The channel terminates in an apparent upland farm pond outside of the study area further west. The drainage class of this channel is ephemeral. Outside of rail ROW, the channel appears to have been impacted by the presence of cattle (erosion, disturbed banks). No wetland fringe was observed in association with this channel. Approximately 470 linear feet were identified in the study area. Channel 1 is not associated with any NWI or NHD data. This channel does not exhibit any apparent connection to WOTUS.

Photo 1: View of Channel 1 from the UPRR ROW. Facing west.

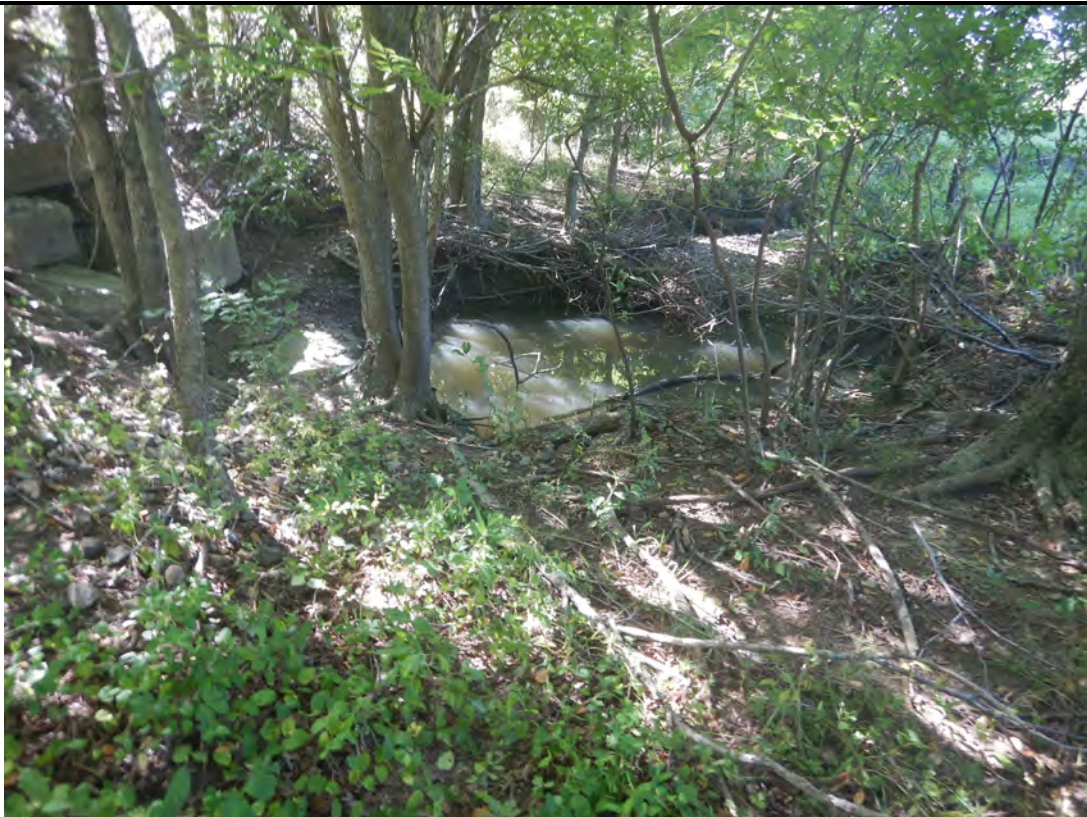
Channel 2 corresponds to Inola Creek. Inola Creek crosses through the study area in two locations. Inola Creek crosses the existing track infrastructure approximately 850 feet east of South 4200 Road. The creek is also present in the southeast portion of the study area associated with the proposed loop track. Inola Creek is a perennial feature, ranging between 20 and 30 feet in width in the study area. The middle section of the study area contained approximately 1130 linear feet. The loop track portion of the study area contained approximately 2,650 linear feet. The creek was observed to be incised, with minimal opportunities for out of bank flooding. No wetland fringe was observed in association with the creek within the study area.

Photo 2: View of Channel 2 and DP 1. Facing south.

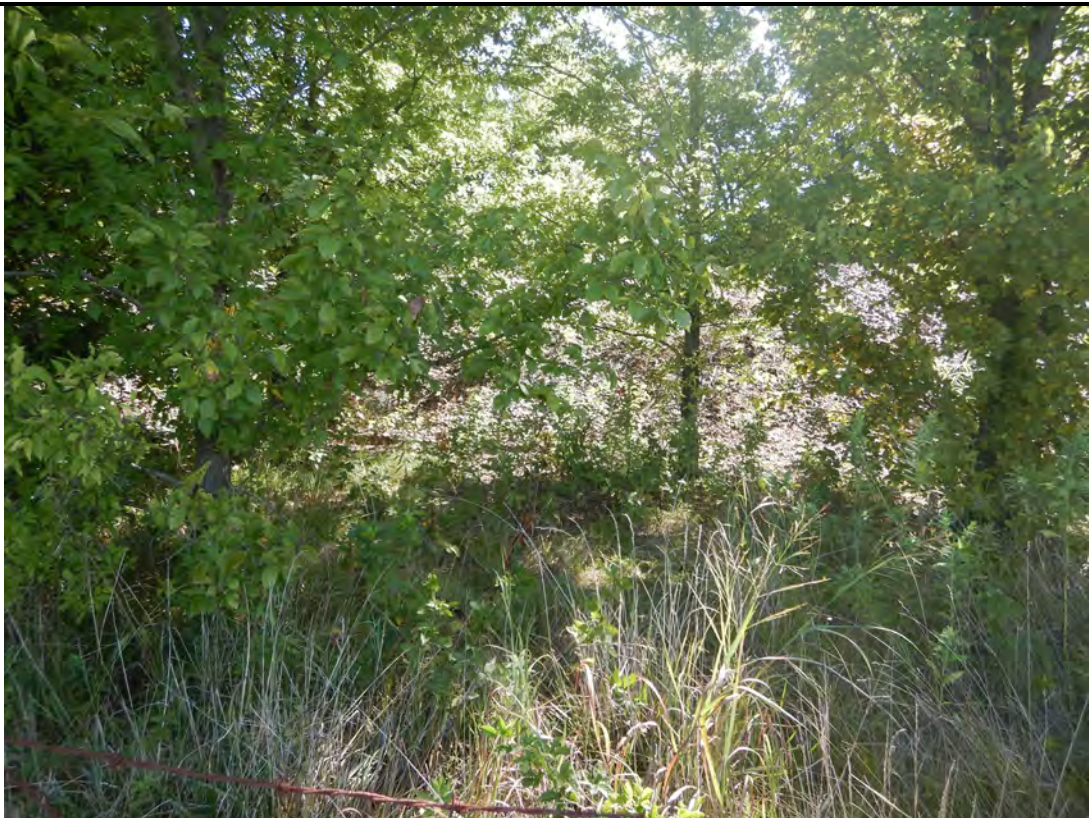
Photo 3: View of the UPRR ROW in an area marked on the NHD layer. No channel features were observed at this location. Facing east.

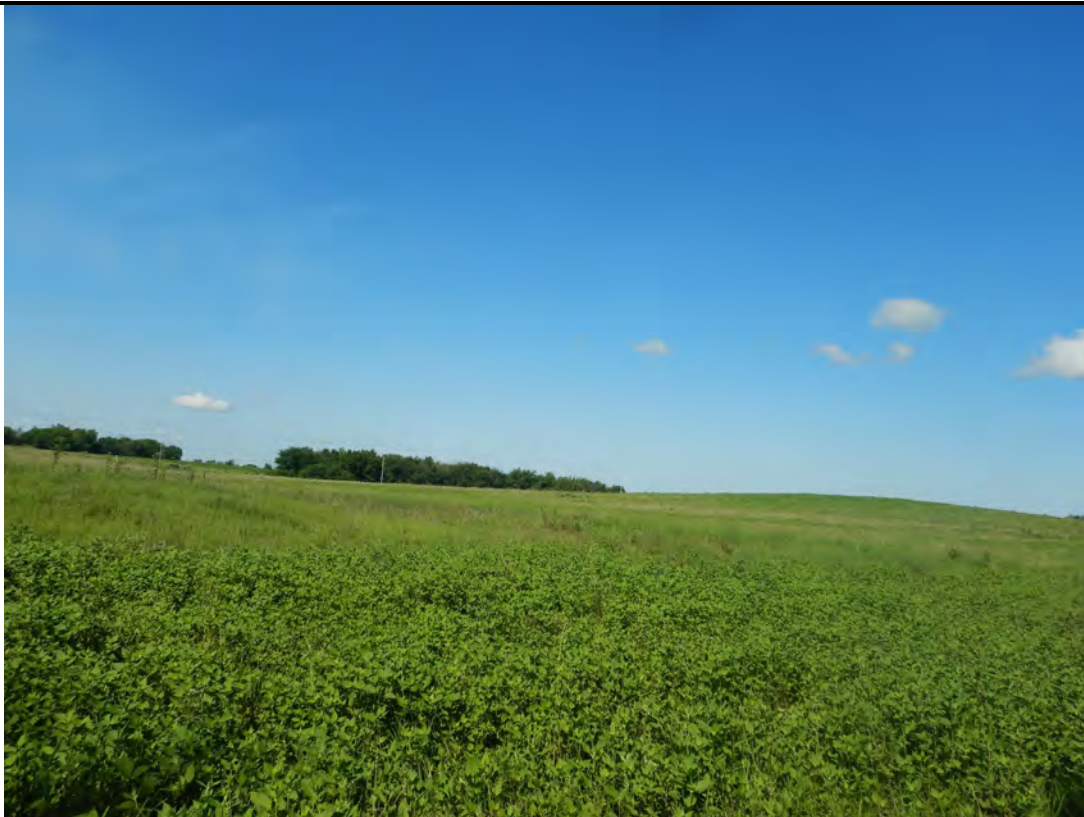
Photo 4: View from the UPRR ROW in an area marked on the NHD layer. No channel features were observed at this location. Facing east.

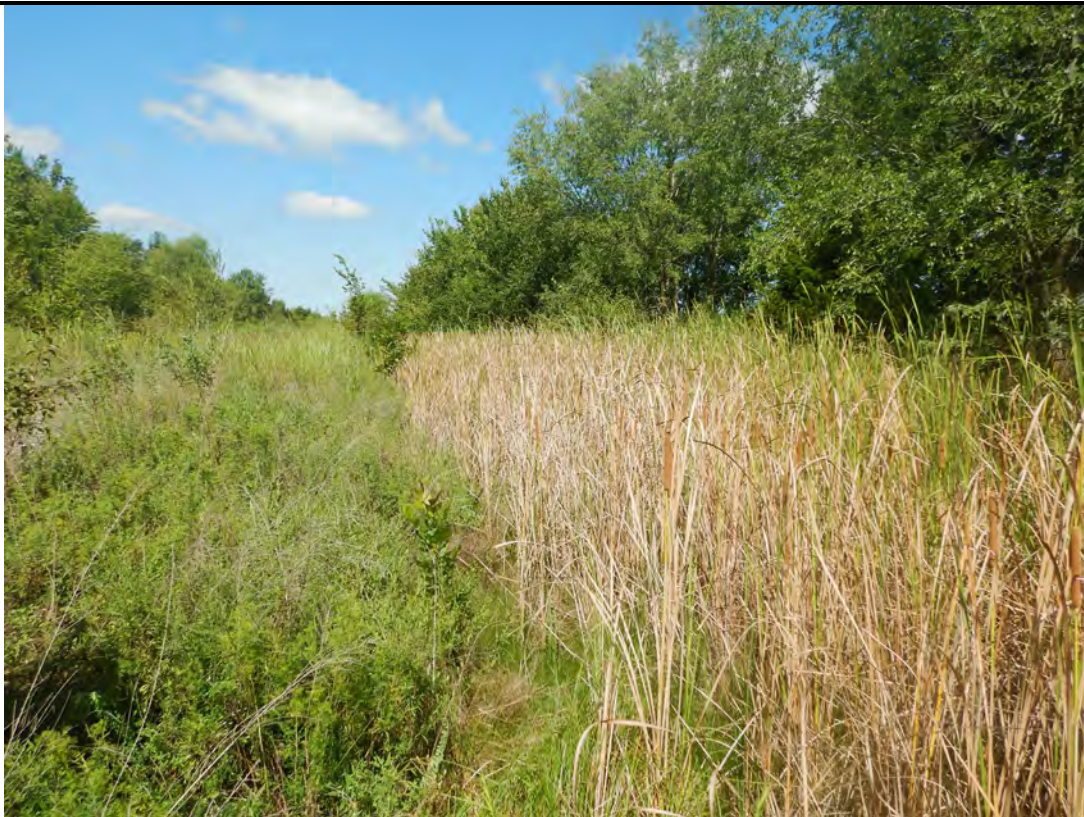
Wetland 1 is a Palustrine Emergent Wetland located in a low area of a ditch on either side of the existing track line. Total observed wetland area is 0.35 acre. The wetland is located at Latitude 36.125239°, Longitude -95.513257°. This wetland is not associated with any NWI or NHD data, and does not exhibit any connectivity to other WOTUS in the area.

Photo 6: View of Wetland 1 on the north side of the existing rail line. Facing west.

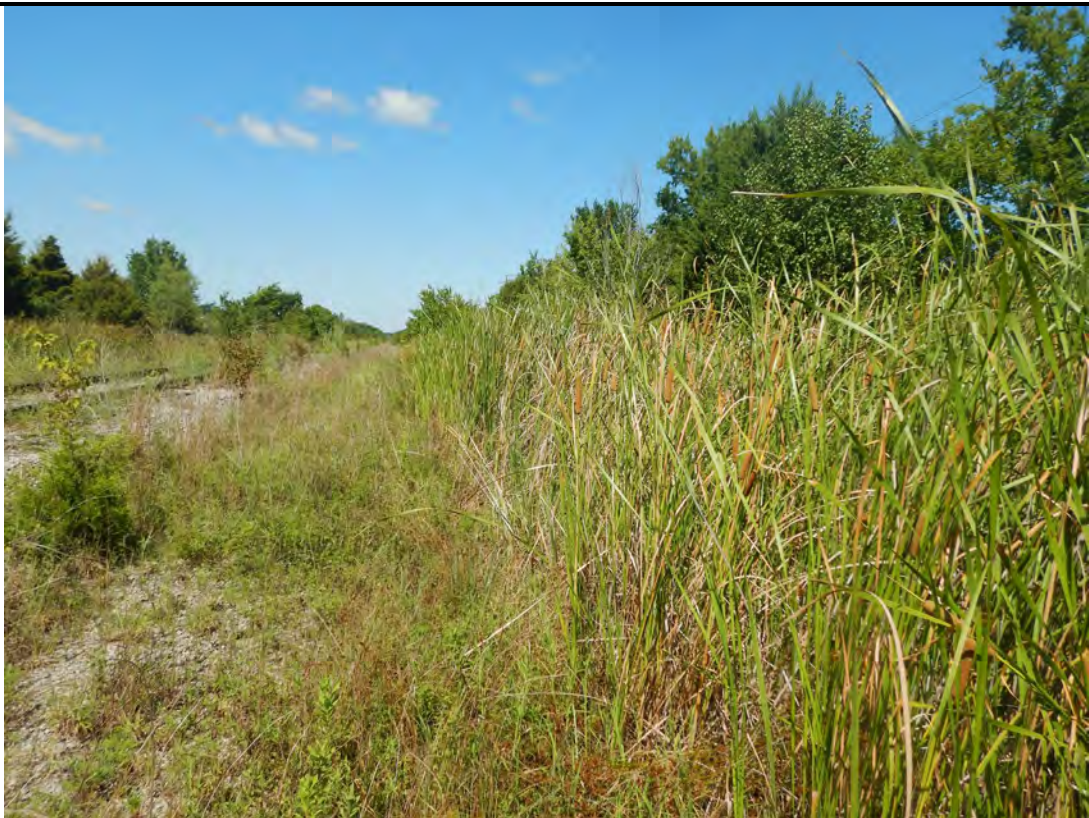
Photo 7: View of Wetland 1 on the south side of the existing rail. Facing east.

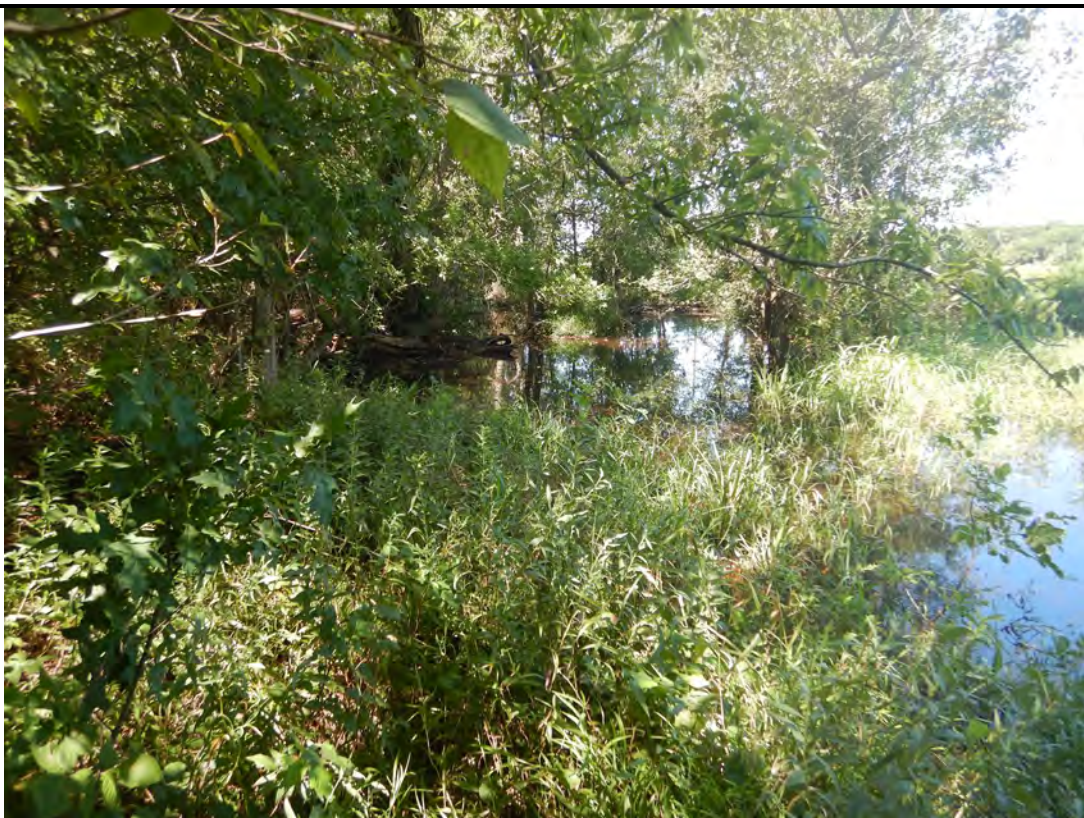
Wetland 2 is a Palustrine Emergent Wetland located in a low area north of the existing rail line. NWI and NHD data indicate the presence of a channel and a freshwater pond at this location. The observed wetland area is 0.59 acres. The wetland is located at Latitude 36.125516°, Longitude -95.521459°. The wetland extends further northeast outside of the study area. Hydrology at this location appears to be driven by inadequate cross track drainage. This wetland may be connected to an unnamed tributary to Inola Creek.

Photo 9: View of Wetland 2 (DP4). Facing west.

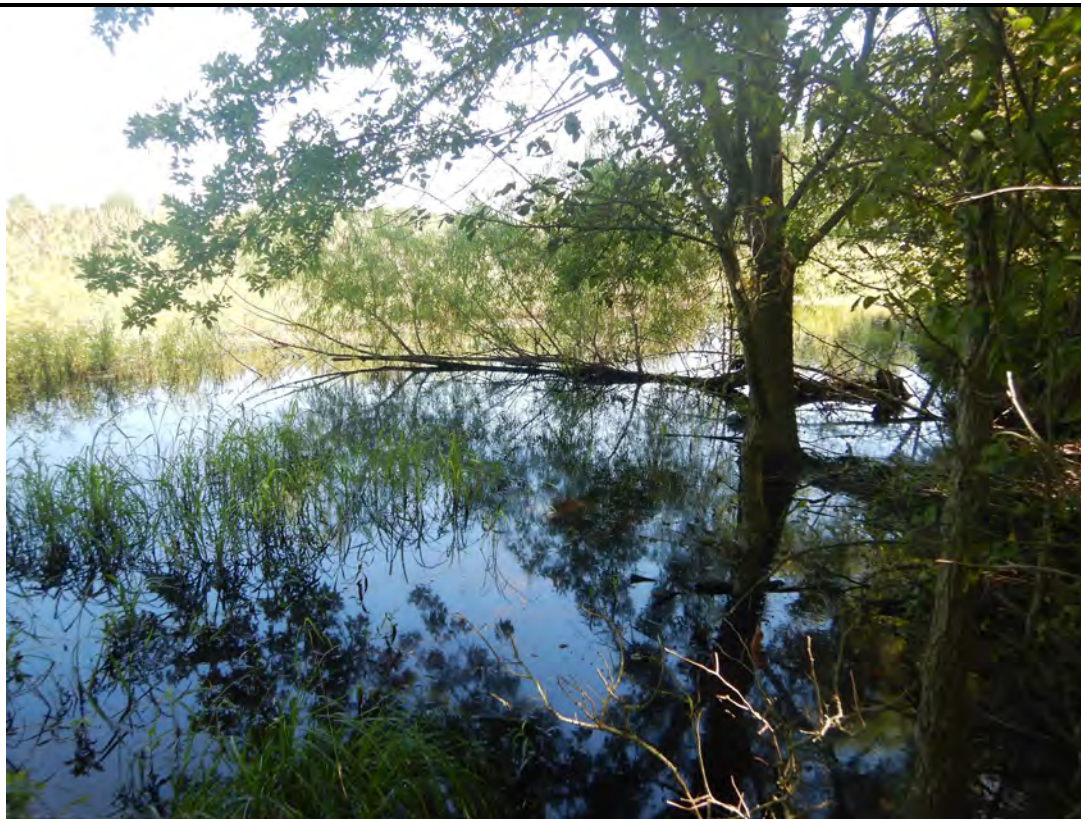
Photo 10: View of Wetland 2 (DP4). Facing northeast.

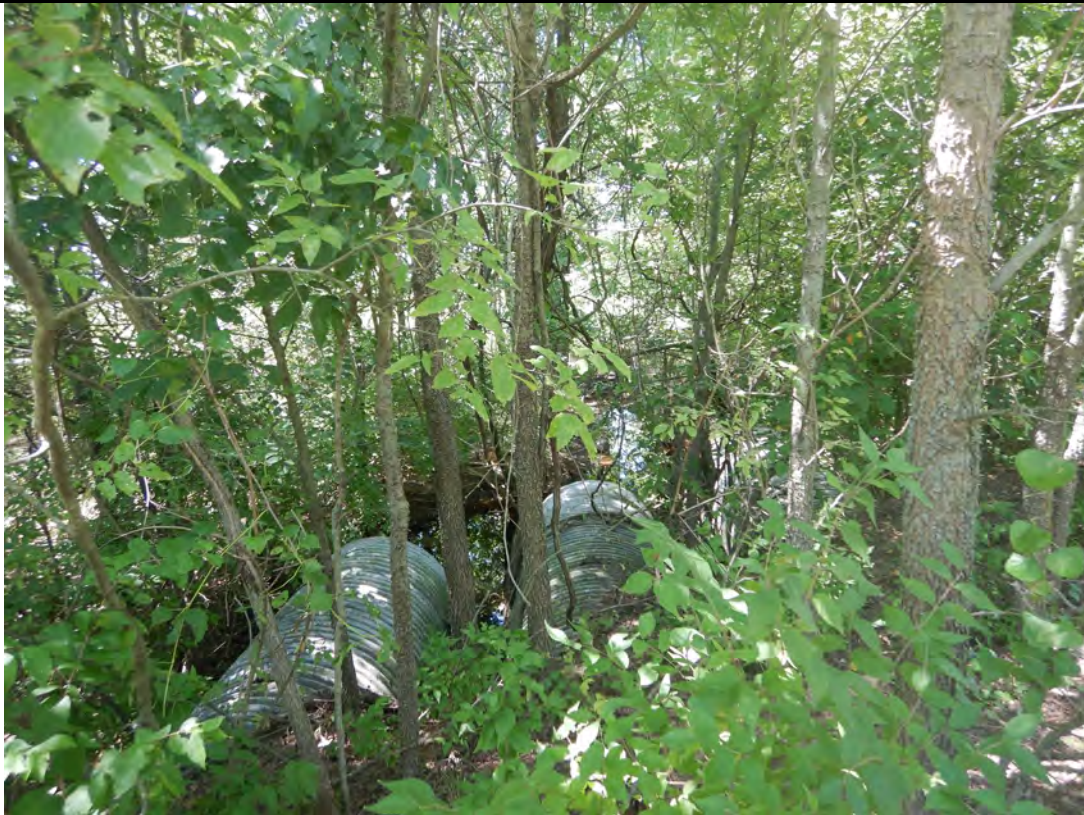
Photo 12: View of a triple pipe culvert approximately 500 feet west of Wetland 2. A channel is present on the south side of the track in this area, outside of the study area. Facing southwest.

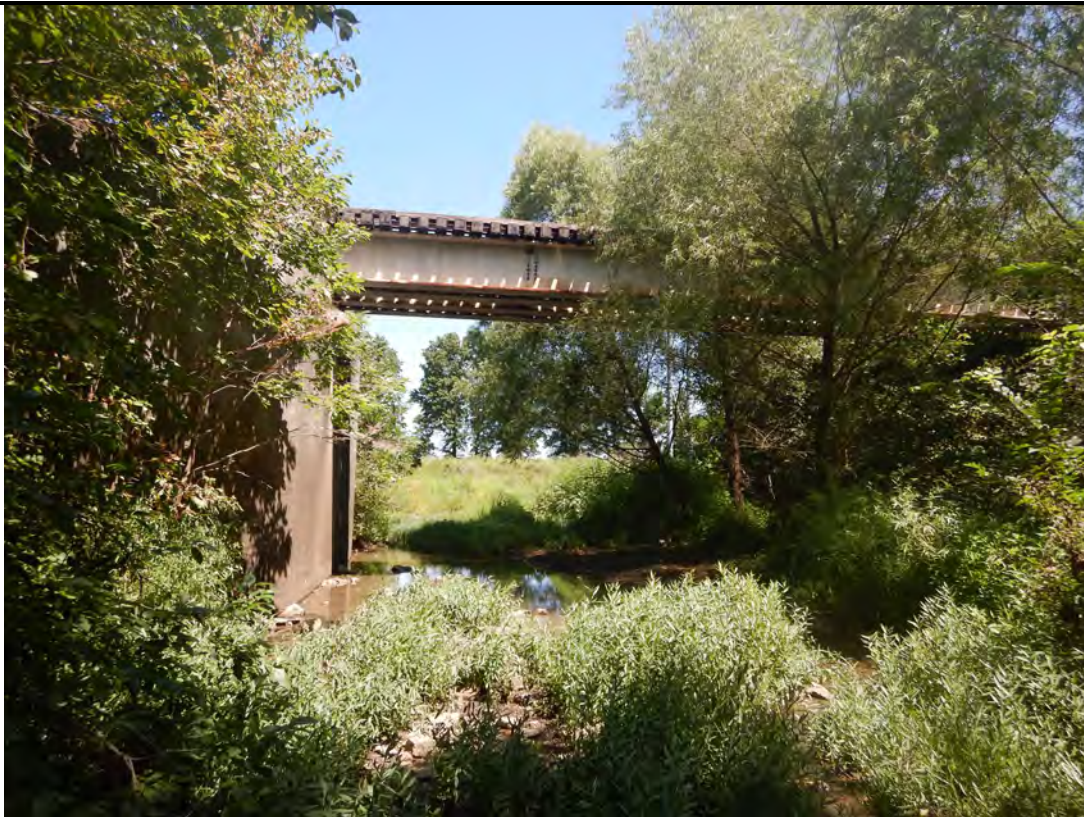
Photo 14: View of the crossing over Inola Creek from the south side of the bridge. Facing north.

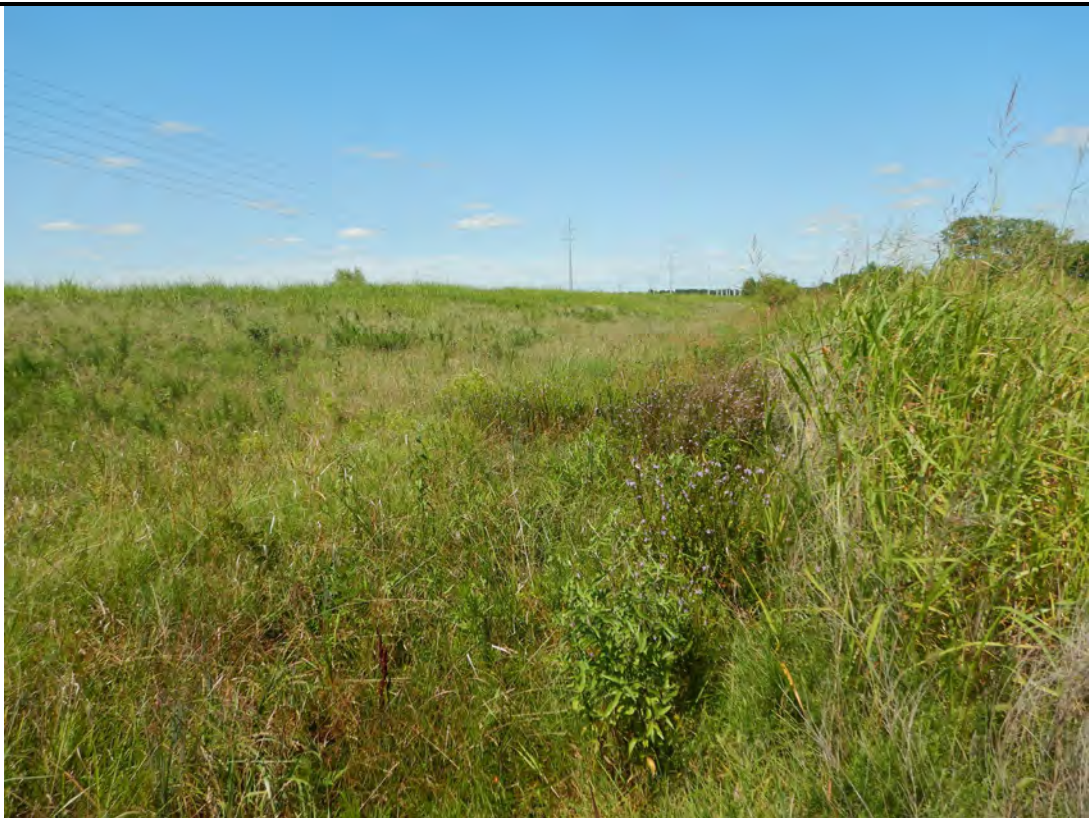
Photo 21: View of Wetland 4 (DP 11) at the base of the rail ballast. Facing northeast.

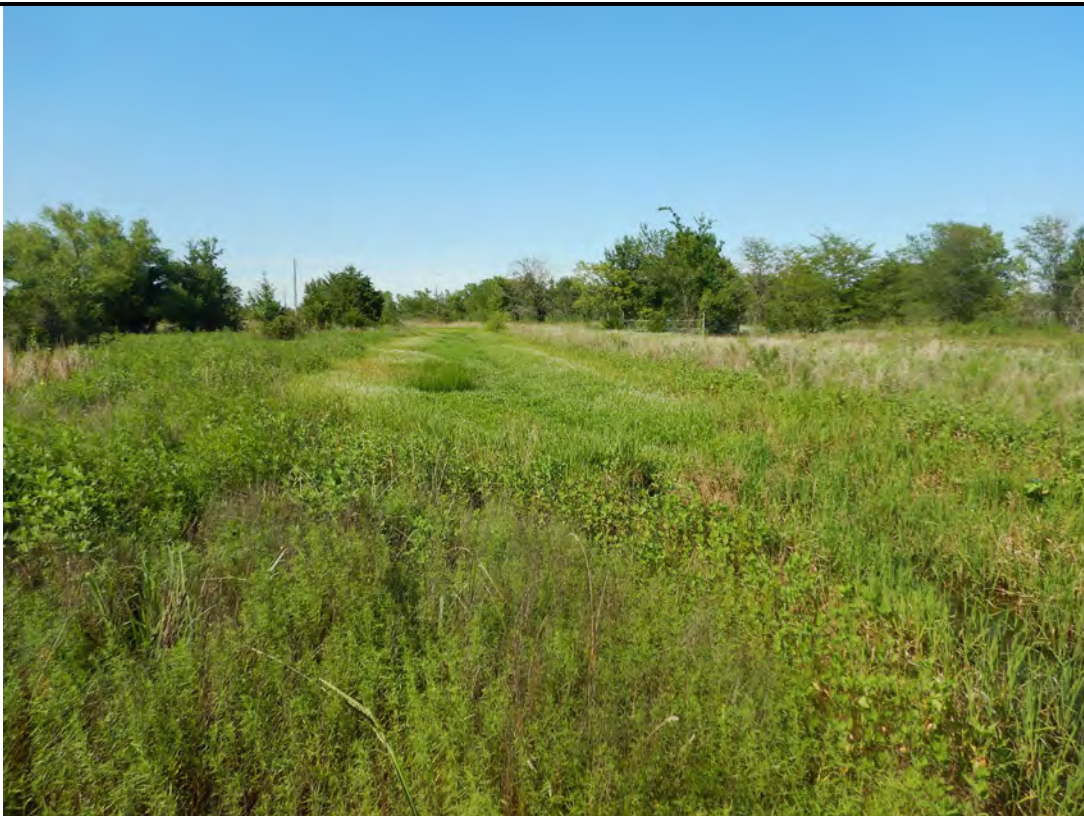
Photo 29: View of Wetland 5 from the midpoint at a break through a culvert. Facing north.

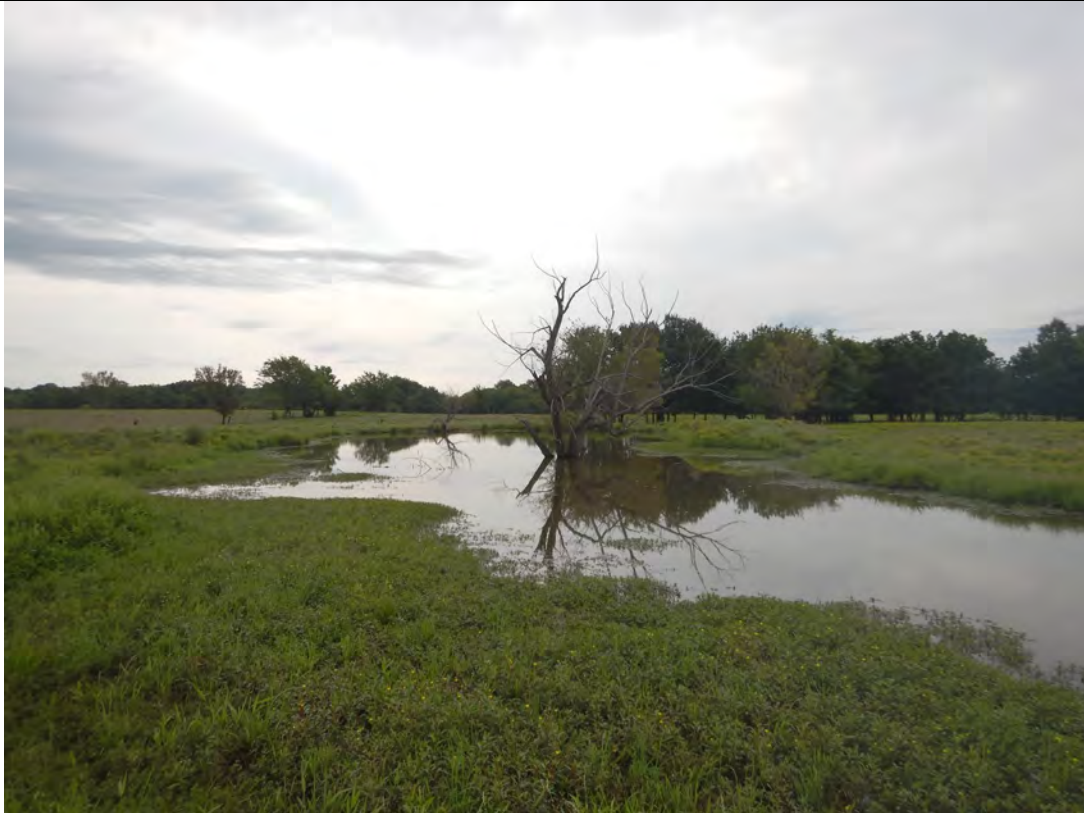
Channel 3 is an ephemeral feature extending from an upland excavated farm pond (Open Water 3). The creek flows from the farm pond to Inola Creek to the south. The channel is approximately 1,350 linear feet in length. Channel 3 is not associated with any NWI or NHD data. The channel appears to have been impacted by the presence of cattle (erosion, disturbed banks). No wetland fringe was observed in association with this channel.

Photo 34: View of Open Water 3, an artificially impounded pond. Facing east.
