Wetland Delineation Report

**Port of Catoosa
Inola Industrial Rail Facility
Rogers County, Oklahoma**

Report Date: October, 2020

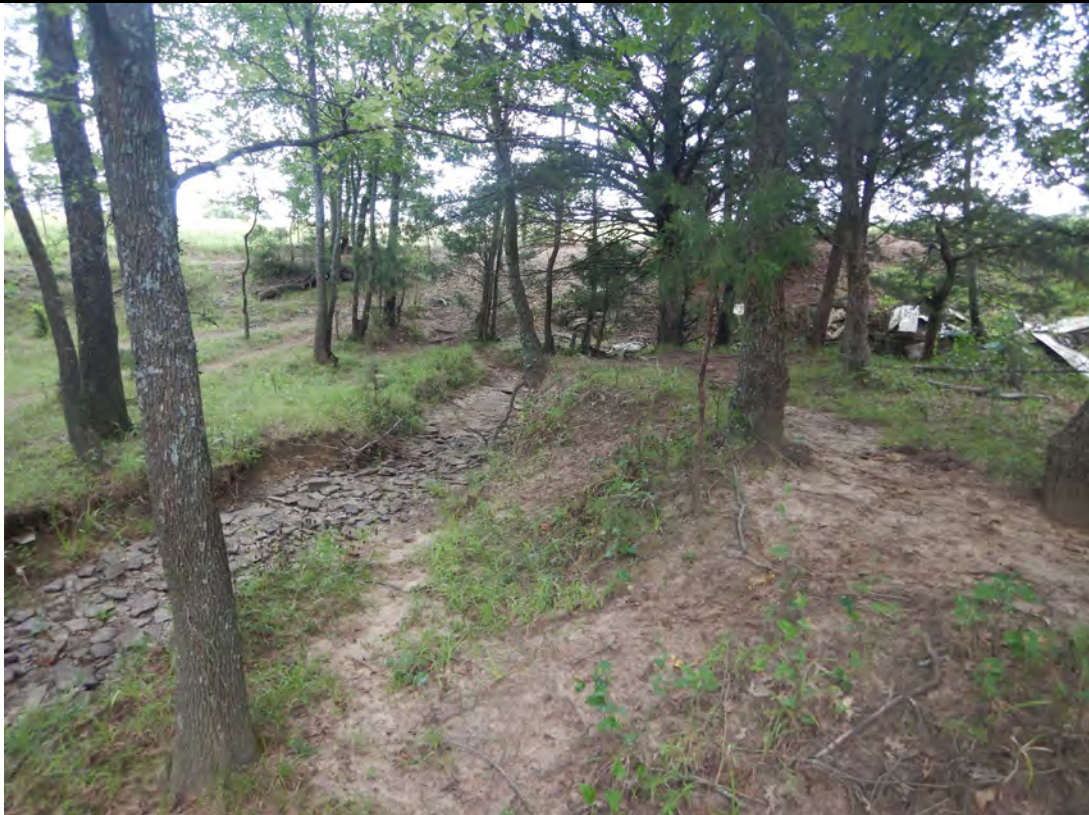
Channel 4 is an ephemeral feature extending from an upland excavated farm pond (Open Water 4). The creek flows from the farm pond to Inola Creek to the southeast. Channel 4 is associated with an NHD channel line. The channel appears to have been impacted by the presence of cattle (erosion, disturbed banks). No wetland fringe was observed in association with this channel. The channel OHWM ceases to be apparent before connecting to the farm pond. The NHD layer channel extends further west than the observed channel. The channel is approximately 1,300 linear feet in length. The NHD layer may be associated with landscape features that were historically present, but have been modified through agricultural and other development.

Photo 36: View of Channel 4. Facing west.

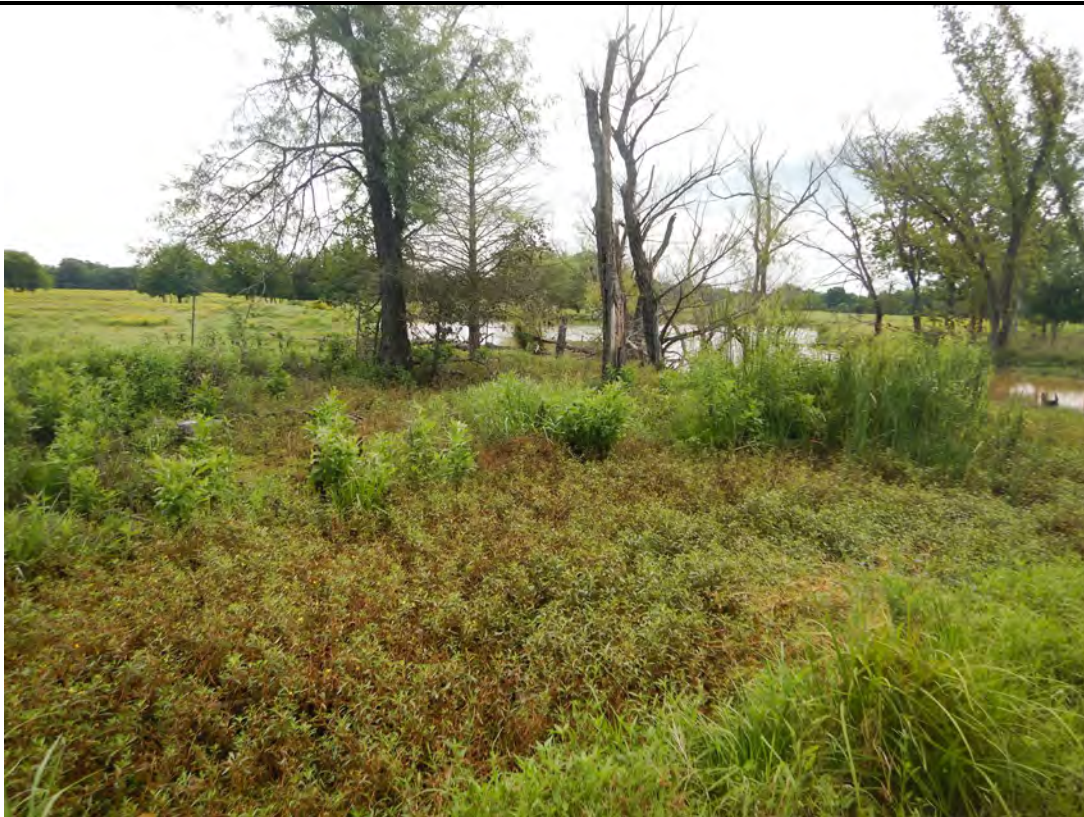
Wetland 7 is a Palustrine Emergent Wetland present as a fringe on the west side of Open Water 4. The area of the wetland is 0.05 acre. The wetland is located at Latitude 36.11823°, Longitude -95.538526°. Wetland conditions appear to be present due to a low area between a dirt access road and the adjacent farm pond.

Photo 38: View of Wetland 7 at DP23. Facing southeast.

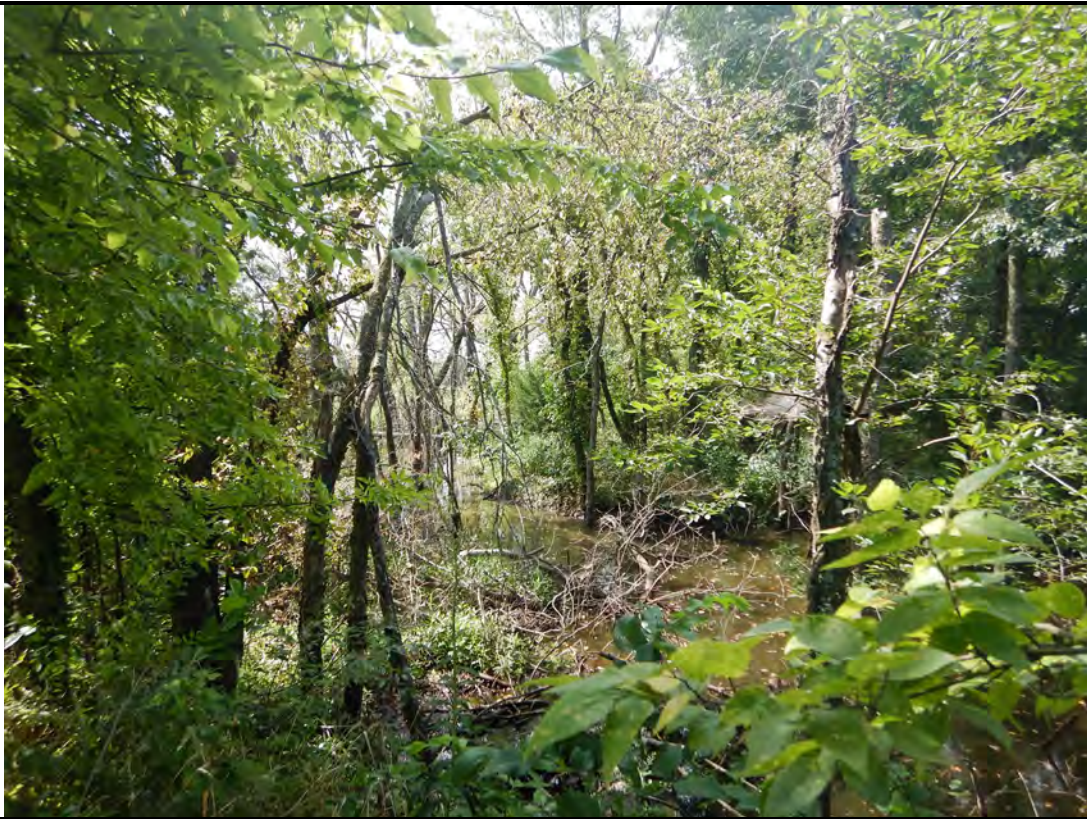
Open Water 5 is a freshwater pond located in a topographically low area. This feature is separated from Open Water 4 by a dirt access road. No water conveyance structure was observed that would connect the two features. The water feature is 0.26 acre in size. NHD and NWI identify this area as corresponding to a channel. Wetland 8 is located on the west side of the feature. No channel was observed extending further north and west from this area, as indicated by NWI and NHD data.

Photo 40: View of Open Water 5. Facing south.

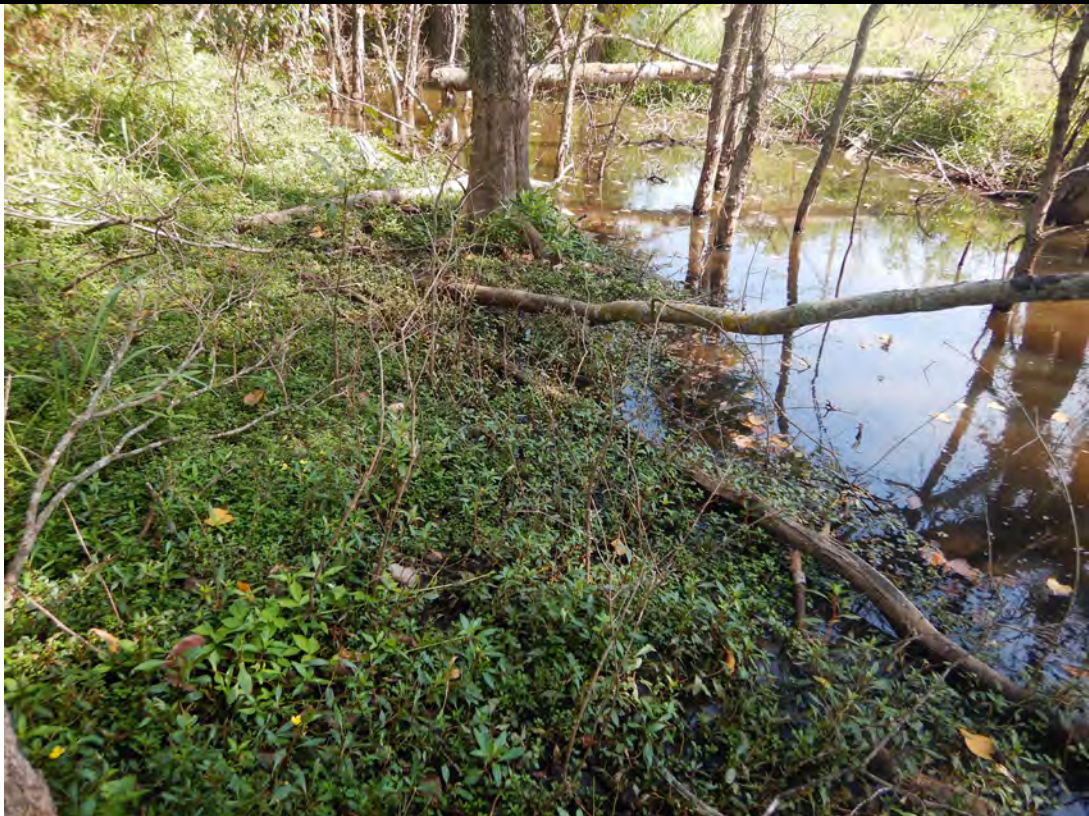
Wetland 8 is a Palustrine Emergent Wetland present as a fringe on the west side of Open Water 5. The area of the wetland is 0.01 acre. The wetland is located at Latitude 36.118568°, Longitude -95.538713°. Topographic conditions supporting wetland hydrology appear to be due to the location of the dirt access road crossing the area.

Photo 41: View of Wetland 8 at DP25. Facing north.
